# NATIONAL TRANSPORTATION SAFETY BOARD

## MATERIALS LABORATORY FACTUAL REPORT

Report No. 03-054

Place : Everglade City, Florida.  
Date : December 30, 2002  
Vehicle : Tour boat "Panther".  
NTSB No. : DCA03MM018  
Investigator : Robert Ford

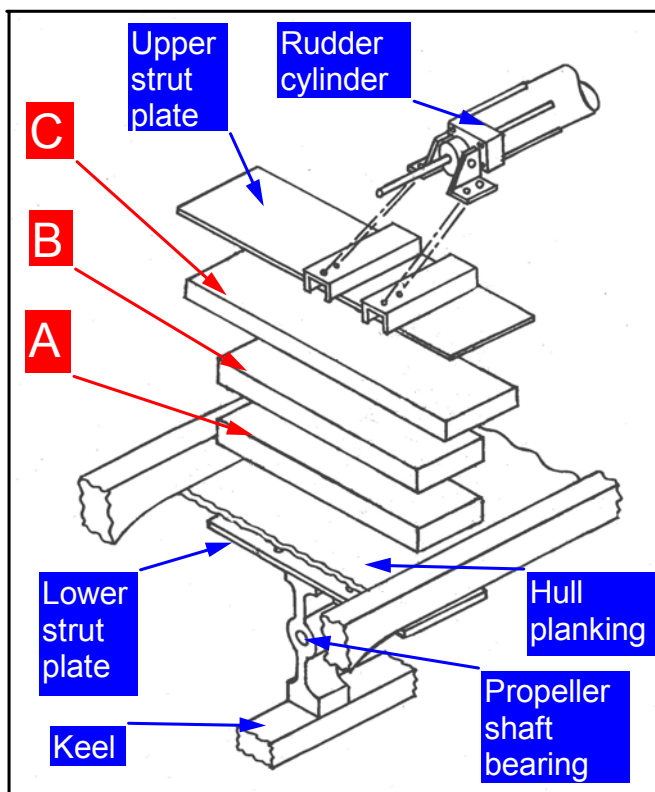
Figure 2. Schematic illustrating the location of the vessel's strut blocks.

In order to illustrate the original location of the received portions on the vessel the isometric sketch illustrated in figure 2 was produced. The strut blocks "A", "B" and "C" are located between the upper strut plate (a metal plate on which the rudder cylinder is also mounted) and the hull planking. A lower strut plate (a metal plate to which the upper end of the propeller shaft bearing support is attached) is located below the hull planking and is, therefore, submerged when the vessel is in use. The lower end of the propeller shaft bearing support is attached to an extension of the keel. The rudder is located to the rear of the propeller, between the hull planking and the keel extension.
